Division of Reclamation,  
Mining and Safety

# Satanic/Bluebird Drilling Investigation and Grouting Project (BIL007 & BIL013)

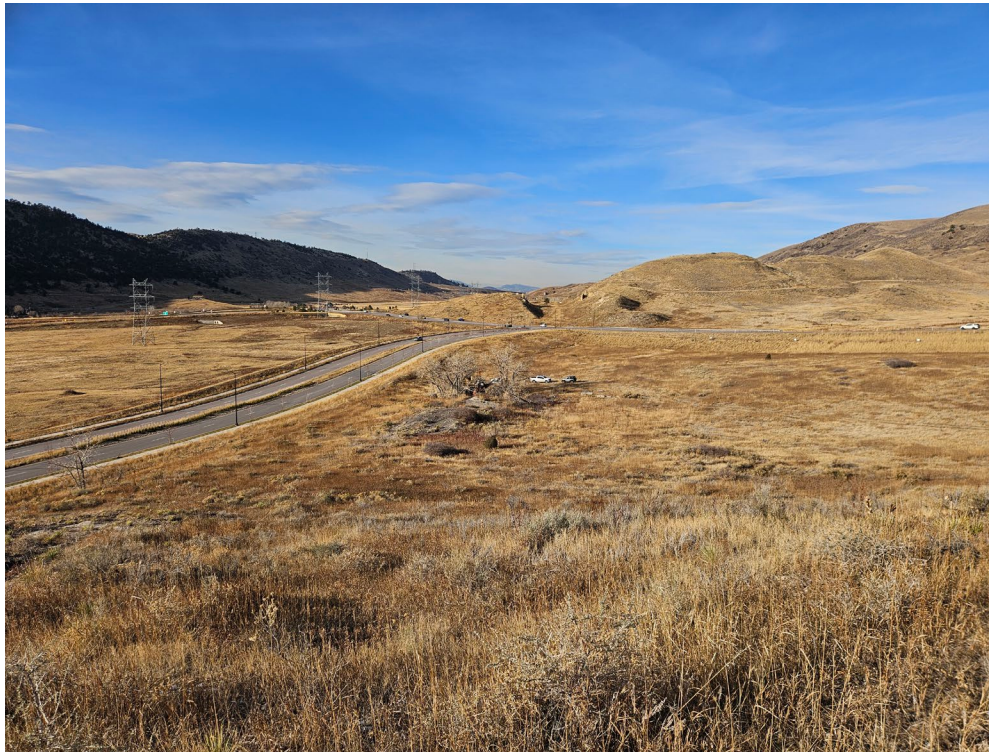
The Satanic/Bluebird mine in Jefferson County is in undeveloped land owned by the City of Lakewood. Mines located in steeply dipping bedrock easily propagate voids to the surface and have caused damage to property along the Denver Basin boundary where they exist. A large depression with mature cottonwood trees over the suspected hoist shaft is an attractive area for nearby public to want to explore, particularly children. This area is under increasingly high development pressure with new high-density residential development occurring or being proposed on the surrounding lands, and open space to the north drawing recreationalists from across the region to the area. Widening of local roads and nearby development has increased water runoff into the area following rain events. The hoist shaft area has been observed holding water after heavy rains, increasing the potential for sudden collapse. The deep mine depth and multiple levels of mining pose a high hazard if collapse were to occur. This project involves two phases: a drilling investigation to determine location and subsurface conditions of the hoist and air shafts, and then compaction grouting to stabilize the shafts. Surface subsidence related to the mine workings is likely to continue to occur.
